Research Article

Acetabular Debonding: An Investigation of Porous Coating Delamination in Hip Resurfacing Arthroplasty

Midlands Orthopaedics & Neurosurgery, 1910 Blanding Street, Columbia, SC 29201, USA

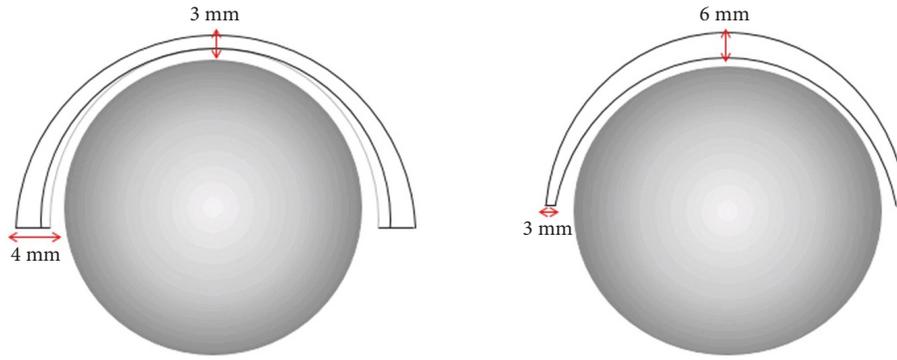
FIGURE 1: Implant design sketches. Corin (left) and Biomet (right) cup dimensions shown, with the gray sphere representing the femoral head.

Both groups employed similar hybrid MoM HRA implants, and each cohort had a minimum follow-up of 10 years. Similarities between the two acetabular components (Table 2) include a cast, high-carbon (>0.2%) CoCr substrate shot blasted with alumina grit and then coated with plasma-sprayed, unalloyed Ti. The coverage arcs are similar between these two implants, but the Group 2 implant arc is 4° less for each implant size on average. There are also several, notable differences in the manufacturing processes of these two devices. The Group 1 implant [24] is double heat-treated, and an additional layer of hydroxyapatite (HA) is plasma sprayed onto the Ti layer. Two sets of relatively thick antirotation fins at the equator imbed into the ischium and pubis during impaction. The Group 2 implant system is not heat-treated and does not have an HA layer. There are four pairs of smaller, thinner fins evenly spaced around the circumference of the implant. Implant dimensions are roughly sketched in Figure 1.

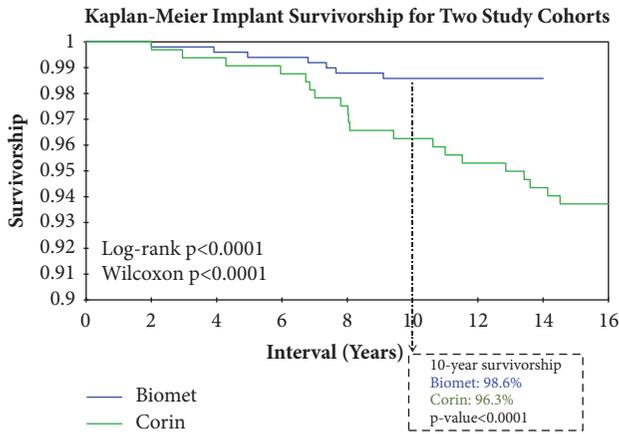
FIGURE 2: Kaplan-Meier implant survivorship for two study cohorts. Kaplan-Meier implant survivorship analysis using late acetabular failure as an endpoint. All cases in both groups have a minimum of 10 years' follow-up. At 10 years, survivorship is 97.2% for Biomet and 96.0% for Corin ($p=0.0008$). Late acetabular failure is defined as failure of acetabular component >2 years. Results of the log-rank test (p value <0.0001) and Wilcoxon test (p value <0.0001) show significant difference in the occurrence of late acetabular failures between the two implant groups.

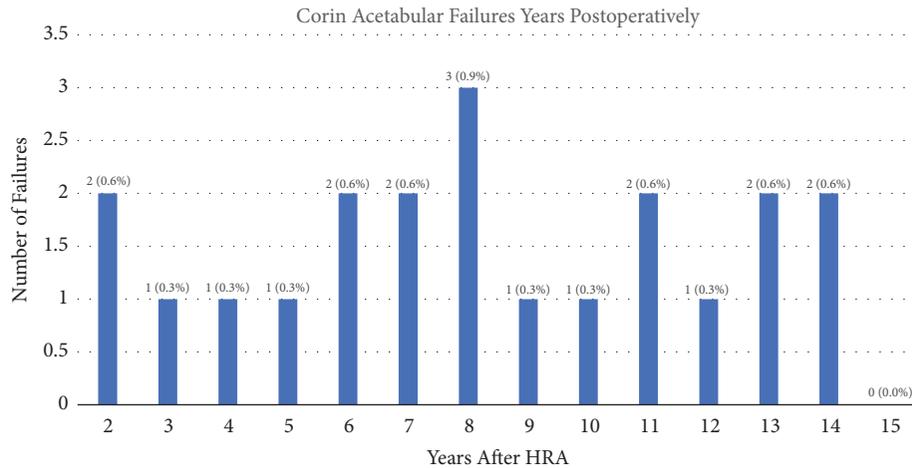
FIGURE 3: Corin late acetabular failure distribution over postoperative time. Figure 3 presents a distribution of Corin acetabular failures over postoperative time. Callouts show number of failures and percentage of the entire cohort (371 cases). Two cases failed before 2 years postoperatively (0.5% of cases) and are considered failure of ingrowth.

Figure 3 presents the number of late acetabular failure cases for Group 1 implant systems, dependent on time since

surgery. Two Group 1 acetabular failures occurred before 2 years (0.5% of total cases) with all other acetabular failures occurring thereafter (5.1%). Failures occurred at a mean of 8.5 years. There were no differences between the time since surgery and rate of late failure. There was no statistical difference between date of HRA surgery and rate of late failure, although we observed most instances of Group 1 debonding were from cases performed in 2002. Manufacturers often use outside suppliers to perform porous coating. Unfortunately, the manufacturer would not provide us with vendor information for failed implants. Therefore, we investigated failure rate of implants from specific time periods; we could not establish any correlation. Group 2 implants failed late at 7 and 8 years. Clinical data (Table 5) indicate a higher postoperative HHS and UCLA activity score for Group 2 (HHS p value<0.0001, UCLA p value<0.0001), as well as lower VAS pain scores on regular and worst days (regular p value<0.0001, worst p value=0.0315). Radiographic data indicate a lower instance of radiolucency (p value<0.005) in Group 2 (Table 5). No debonding cases presented radiolucency. Nine debonding cases (69.2% total debonding cases) presented AIA over the relative acetabular inclination limit (RAIL) [32] on their earliest postoperative radiographs, as compared to 94 or 227 measured radiographs (41.4%) from Group 1 ($p=0.04$) (Table 6).
